*Peñuelas Valley Landfill, LLC.  
PO Box 918  
Punta Santiago, PR 00741-0918*

June 22, 2017

**Re: Administrative Compliance Order  
Peñuelas Valley Landfill, LLC./EC Waste, LLC.  
Docket Number CWA-02-2017-3103  
NPDES Tracking Number PRR053203  
Progress Report**

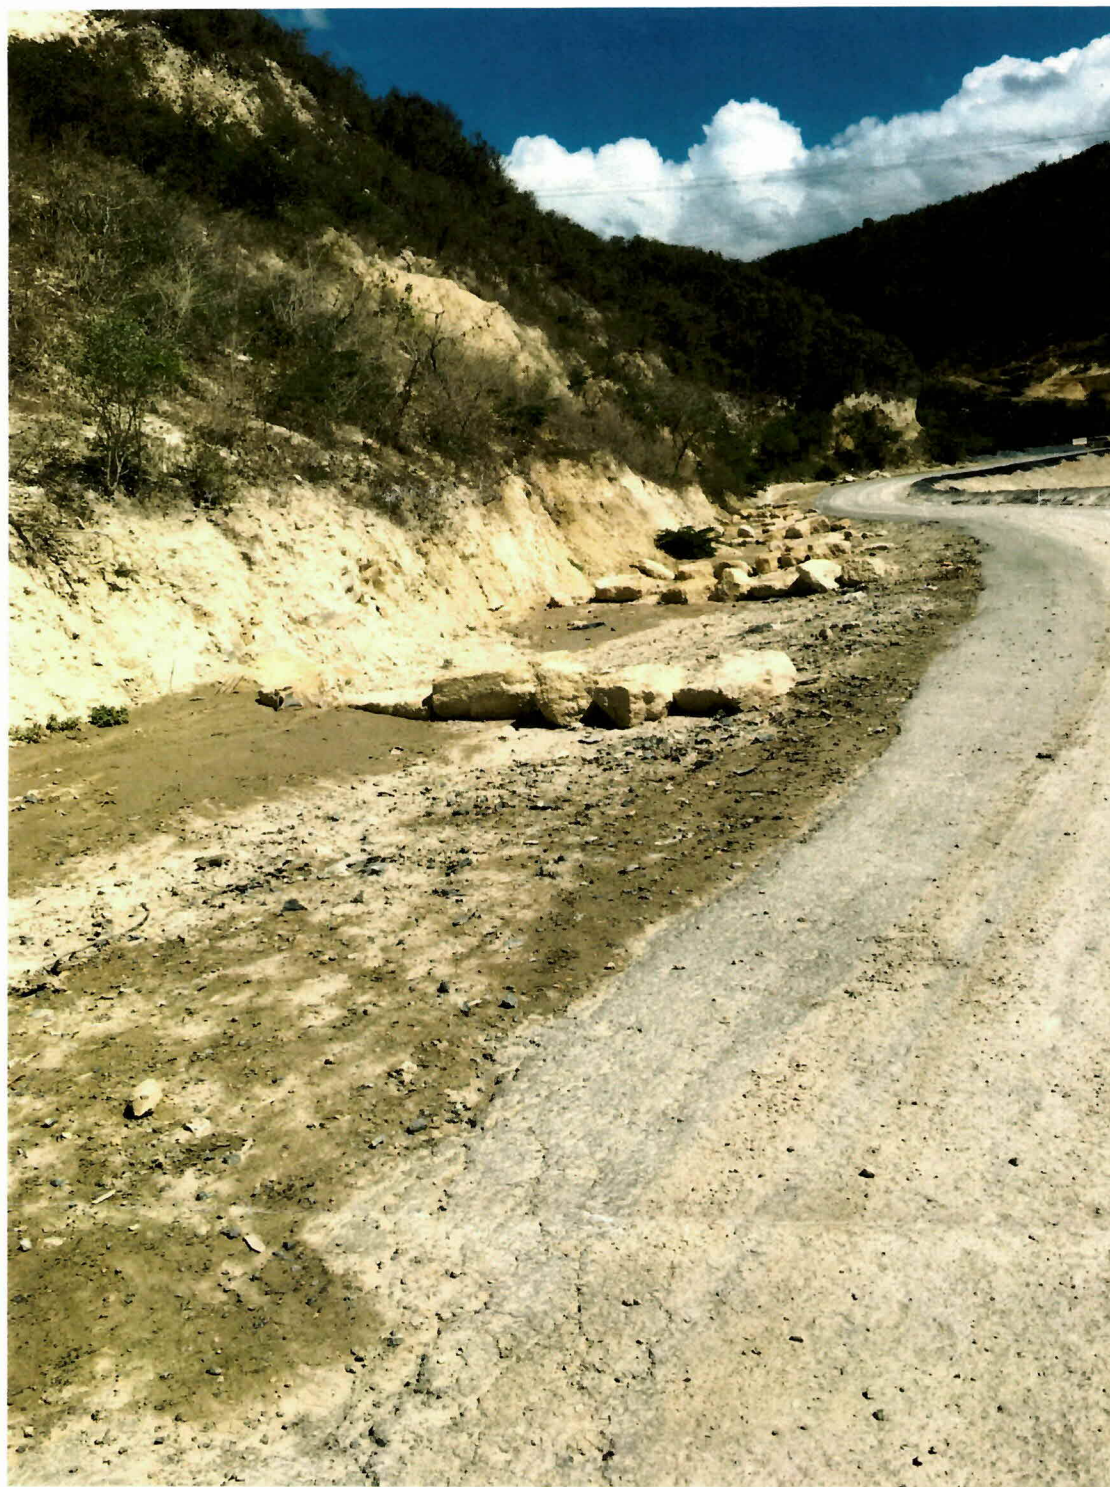
*Photo 1 Energy dissipaters in drainage ditch west of the active cell.*

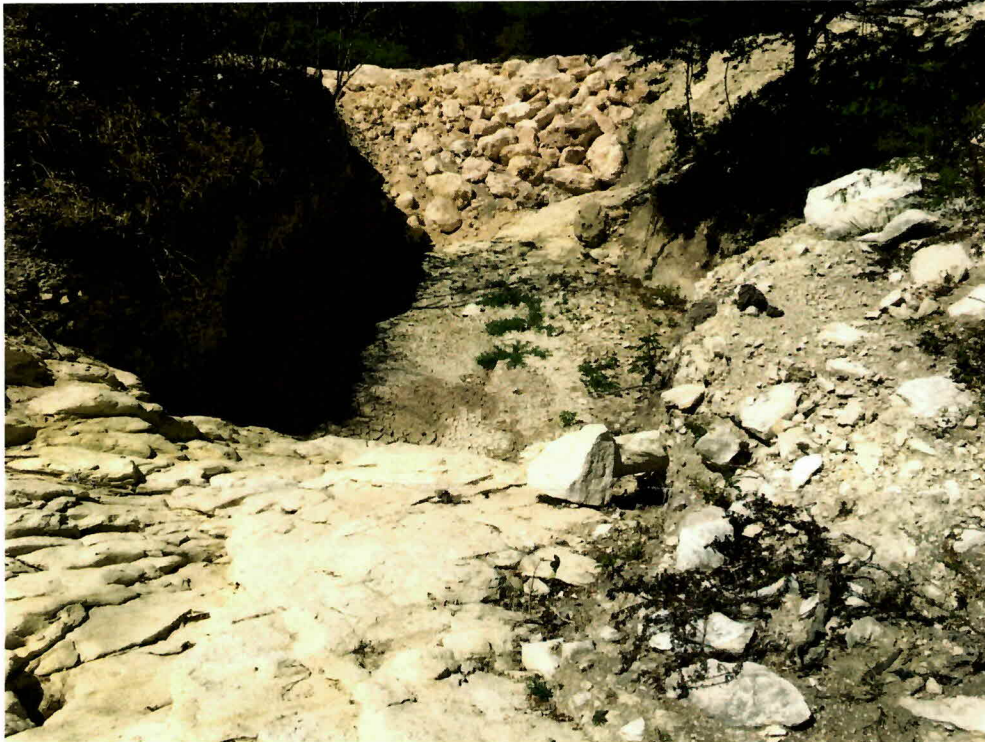
*Photo 2 - Intermediate sediment trap at entrance to sedimentation pond.*

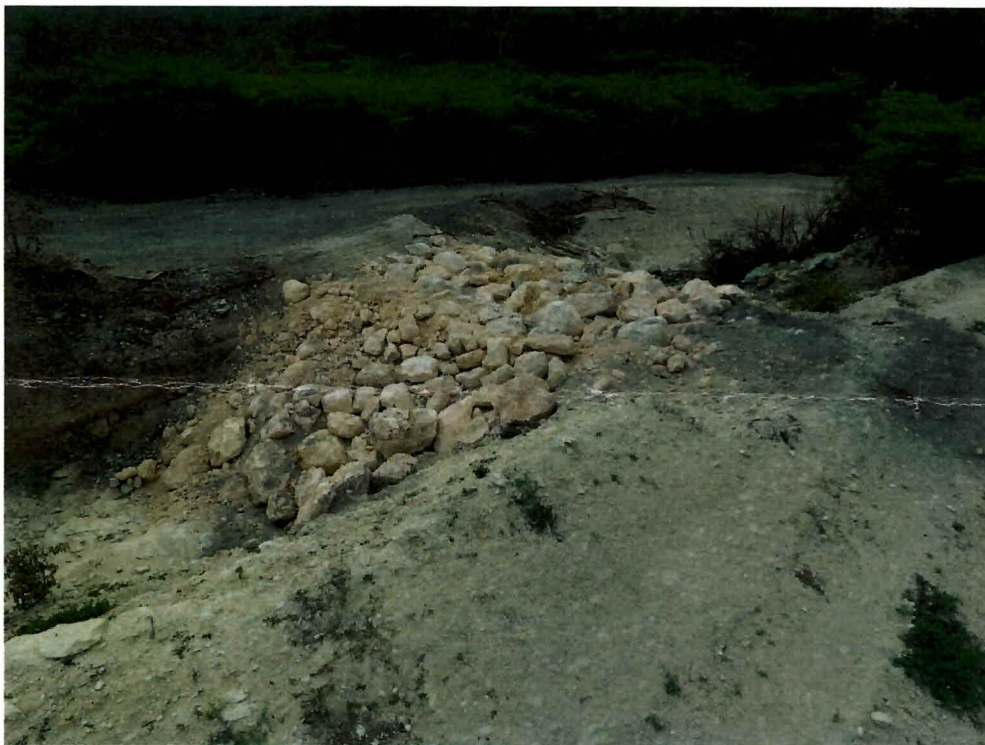
*Photo 3 - Intermediate sediment trap rock wall*

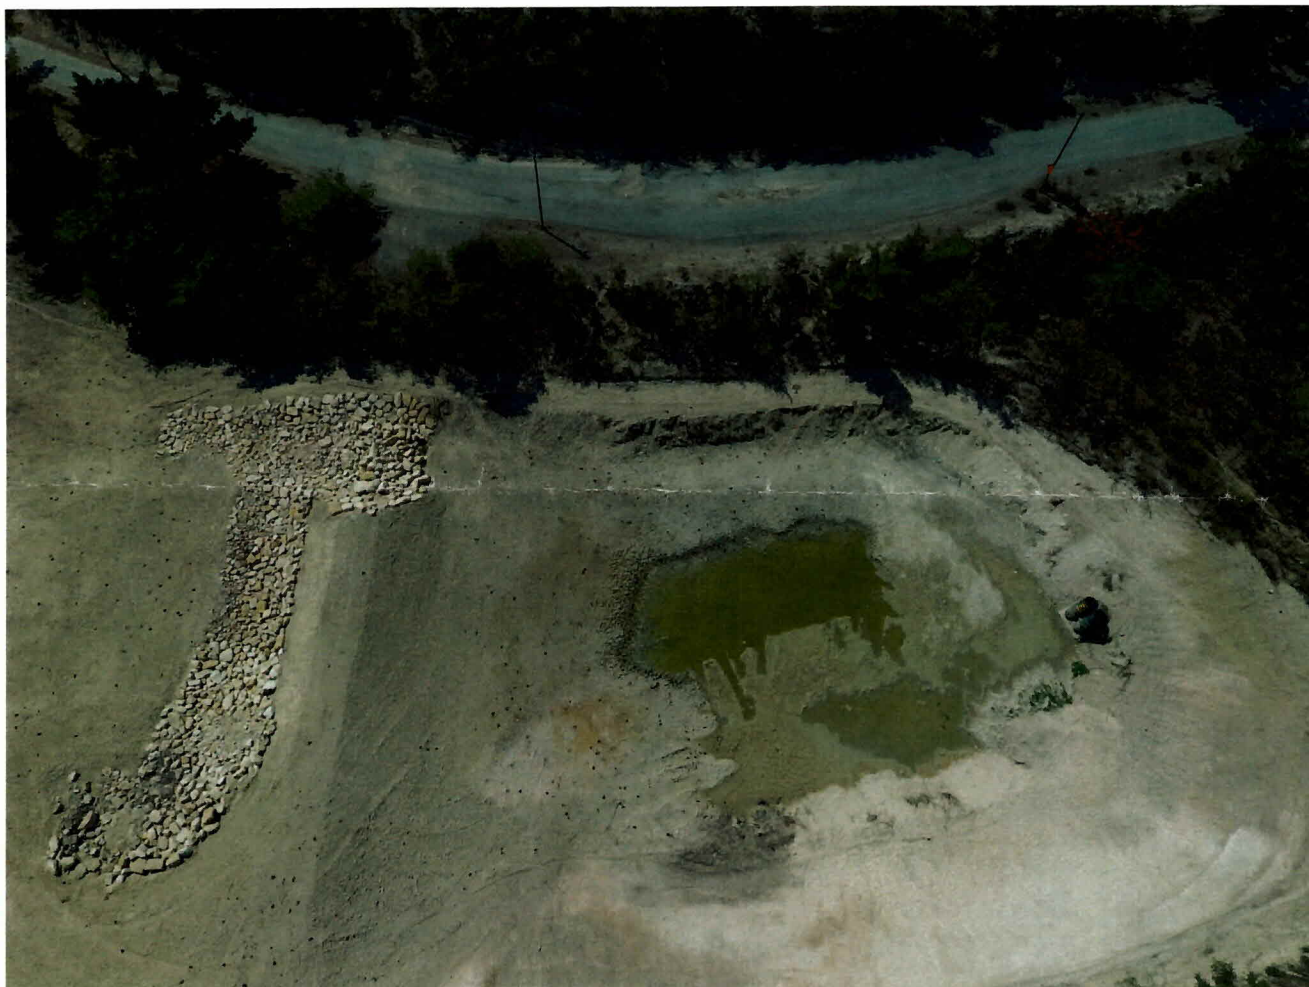
*Photo 4 - View of sedimentation pond with intermediate berm to the left.*

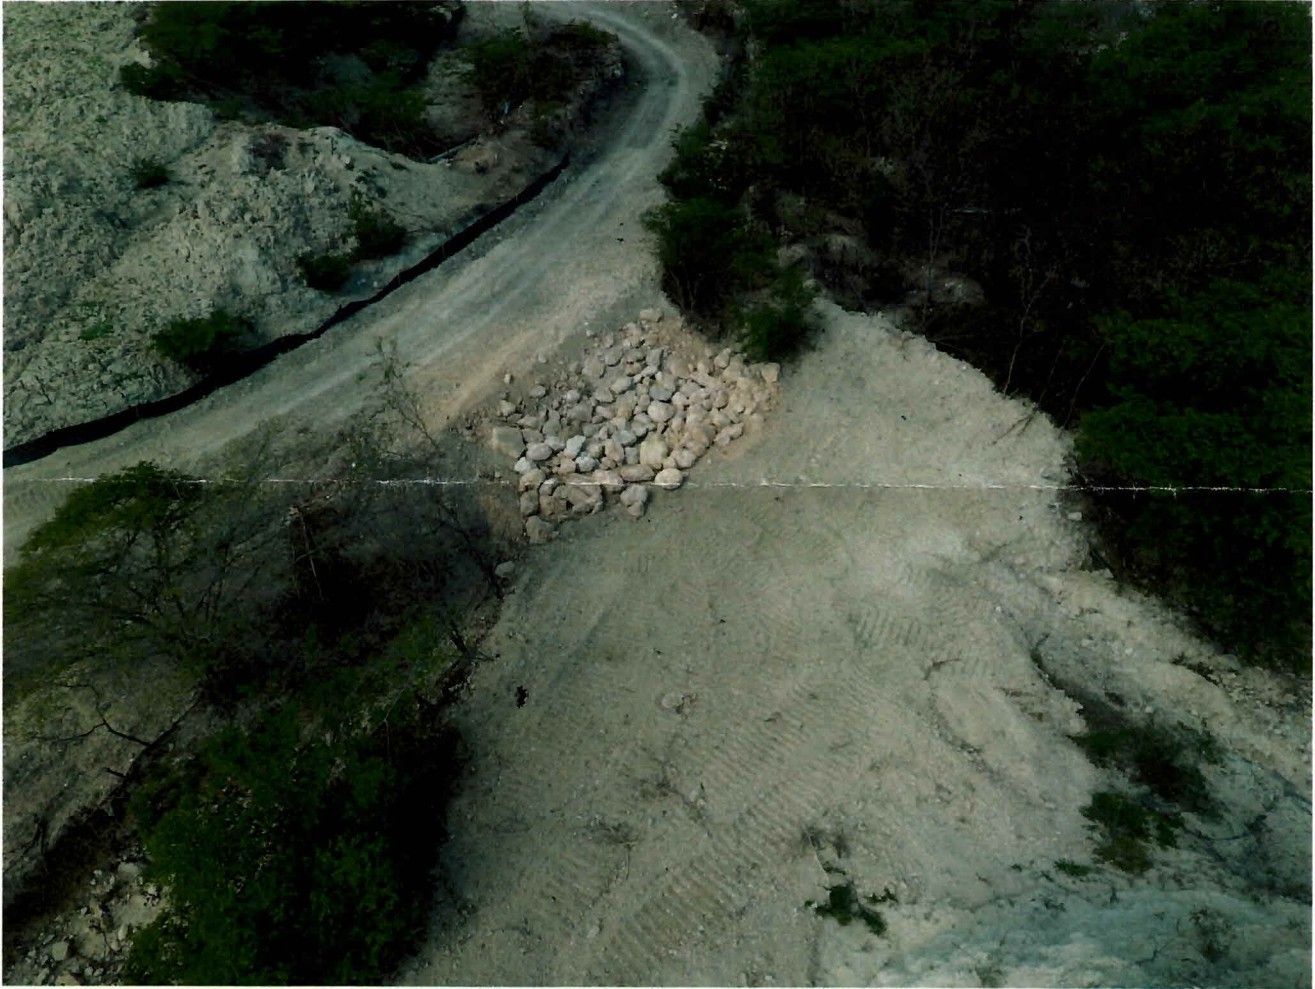
*Photo 5 - Intermediate sediment trap and silt fences*
